HEDGE MANAGEMENT PLAN FOR SAINT-GAUDENS NATIONAL HISTORIC SITE

CORNISH, NEW HAMPSHIRE

Olmsted Center for Landscape Preservation
National Park Service, Boston, Massachusetts, 2008

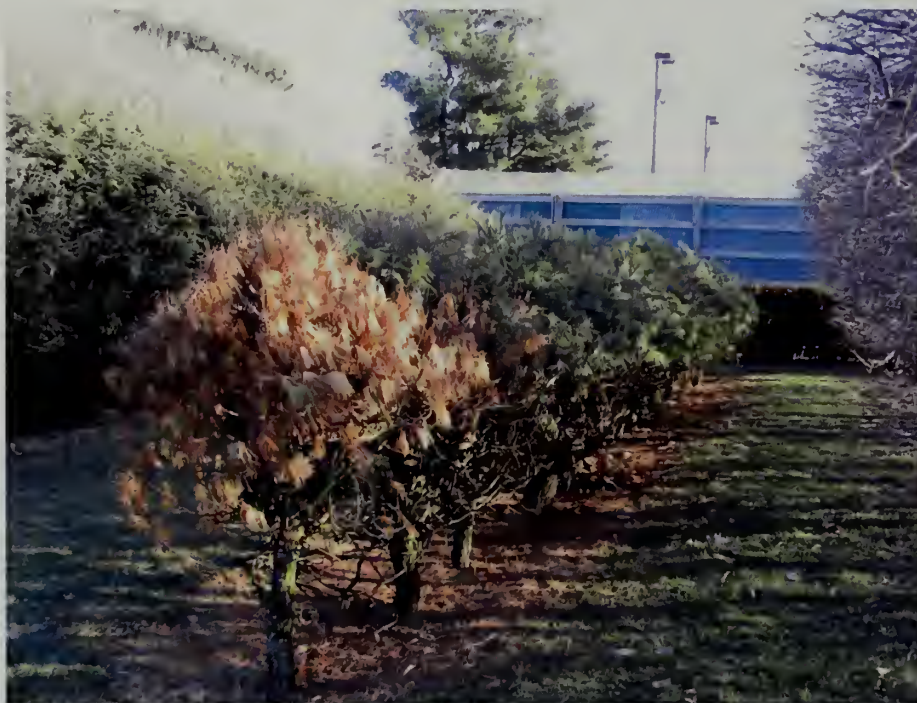
Figure 0.4: A current view of the same white pine hedge as shown in figure 0.3, illustrating loss of lower canopy most likely due in part to increased level of shade, 2006 (SUNY ESF).

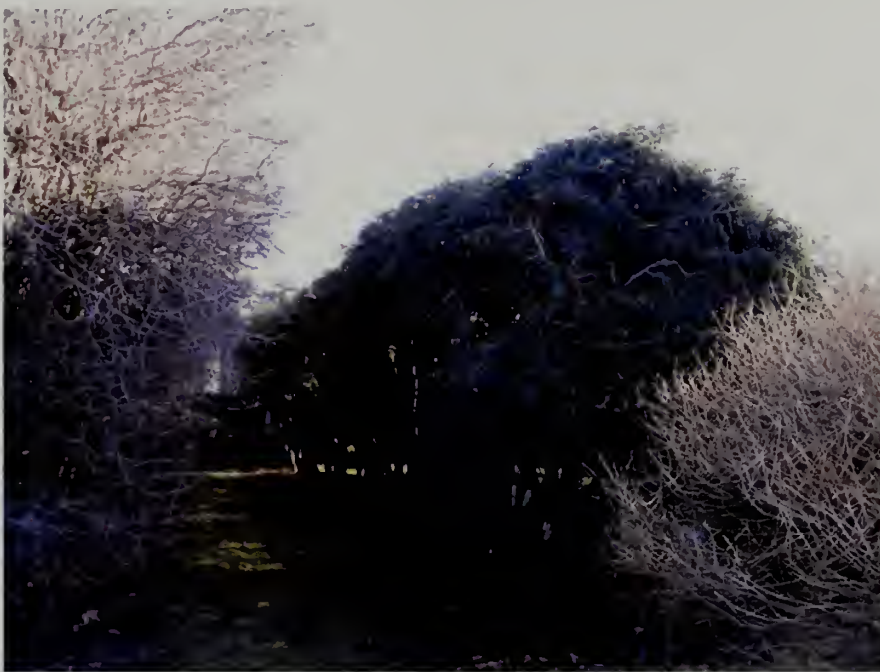
Figure 0.6: Hemlock hedge (similar to figure 0.5) at the Canadian Central Experimental Farm in Ottawa, planted in 1889, photographed 2007. Note loss of side canopy, probably due from excessive shade from adjoining hedge (SUNY ESF).

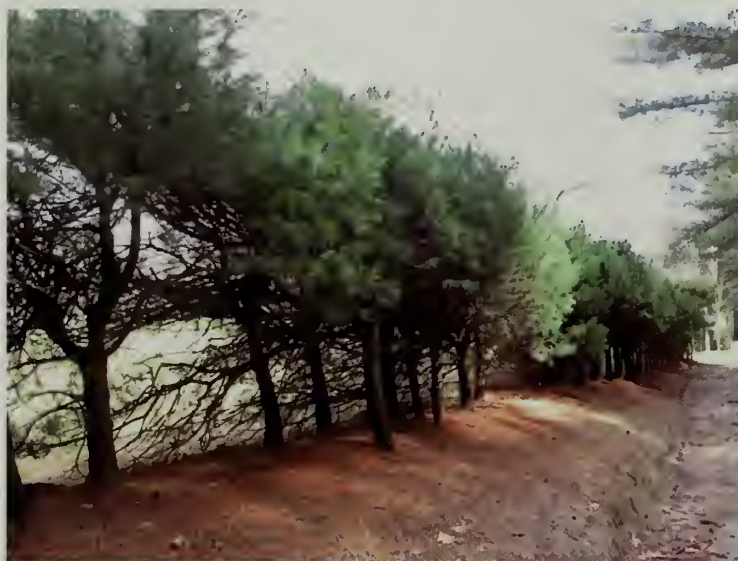
Figure 3.1: West meadow hedge, view looking east along Saint Gaudens Road showing character of c.1970 plants thirty-six years after planting, 2006. Note bare side canopy on the road side (right) and lack of even canopy (Olmsted Center for Landscape Preservation).

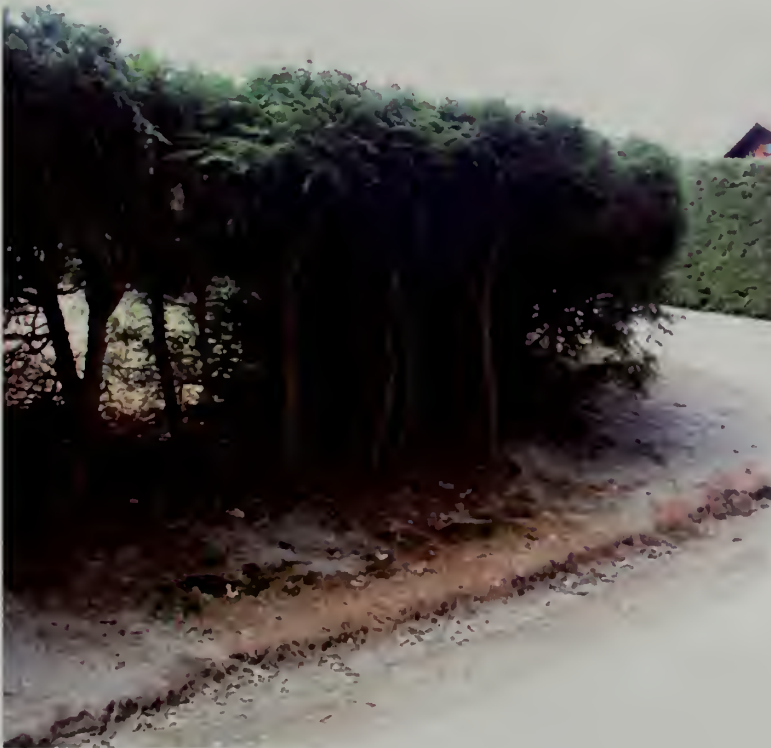
Figure 3.10: The cutting garden hedge, view looking northeast at bare understory of section H-5 facing Saint Gaudens Road, 2006. The gray sediment is left over from winter snowplowing (Olmsted Center for Landscape Preservation).

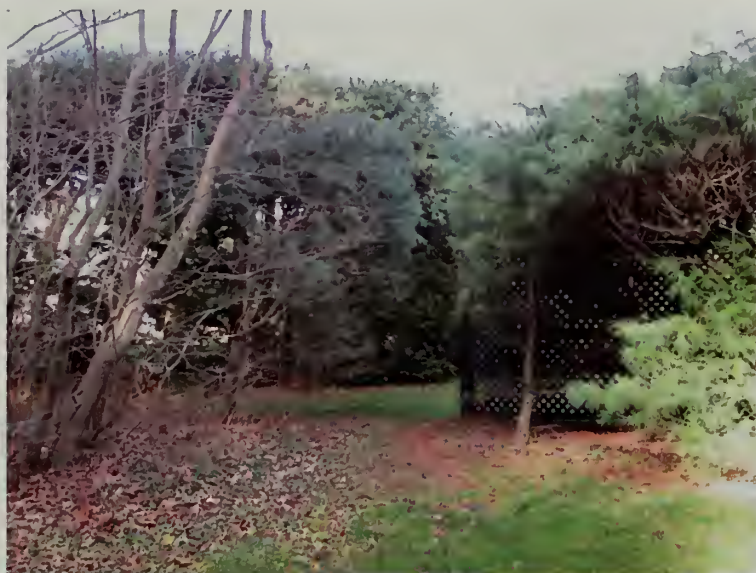
Figure 3.11: The cutting garden hedge, view looking northwest at the gap in the west end of section H-6, 2006. Note the Japanese tree lilac hedge at left and the kitchen hedge in the background (SUNY ESF).

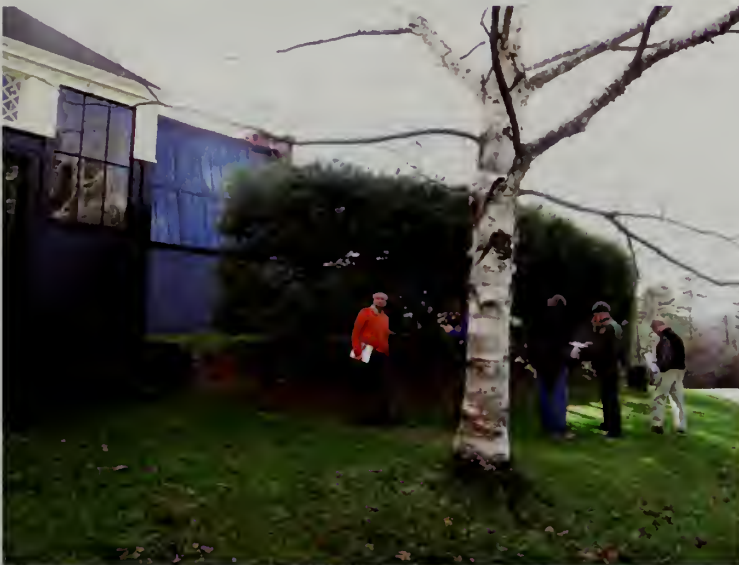
Figure 3.20: The Little Studio hedge view looking west showing non-historic alignment and opening, 2006. (SUNY ESF)

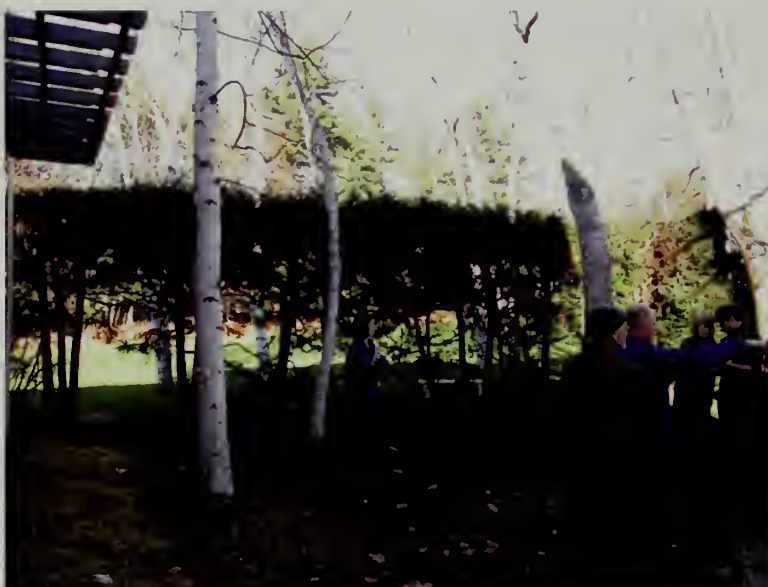
Figure 3.23: The Pan grove hedge, view looking north at section H-10 showing weak canopy and non-historic opening/path, 2006 (SUNY ESF).

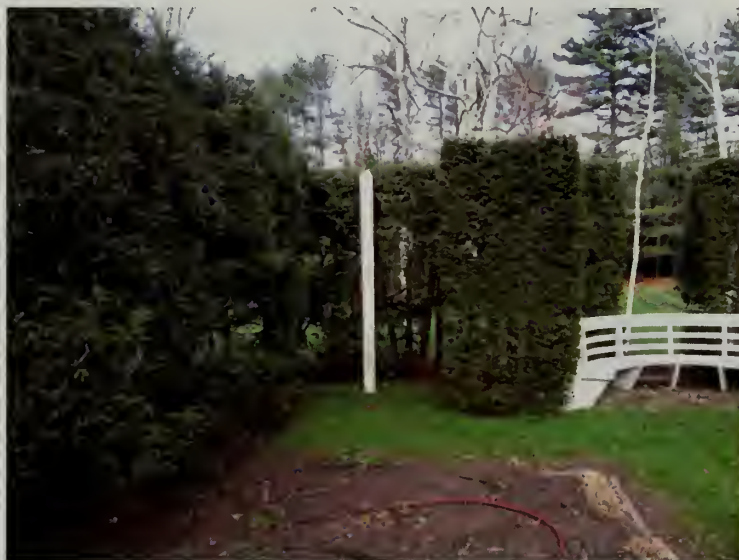
Figure 3.28: The terrace garden hedge, view looking north at a detail of H-12, 2006. Note curved alignment around bench, recess around post, and weak side canopy (SUNY ESF).

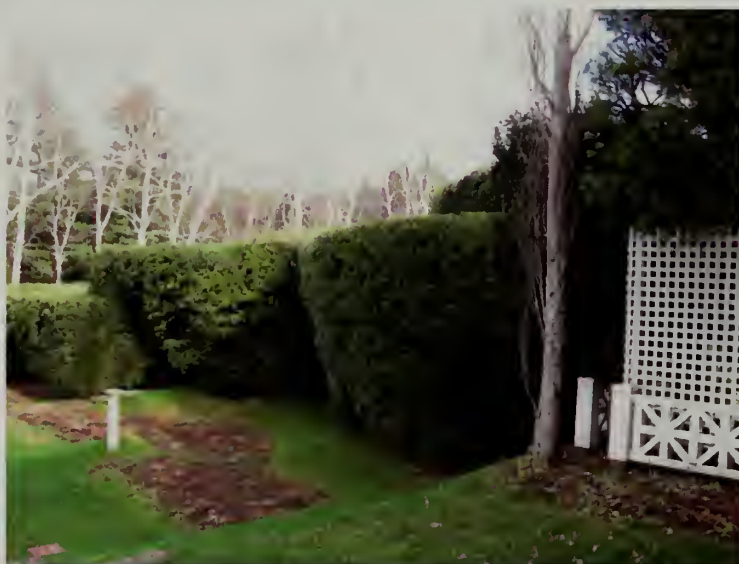
Figure 3.29: Section H-13 of the terrace garden looking northeast from the upper terrace, 2006. Note inward batter toward the base and convex alignment (SUNY ESF).

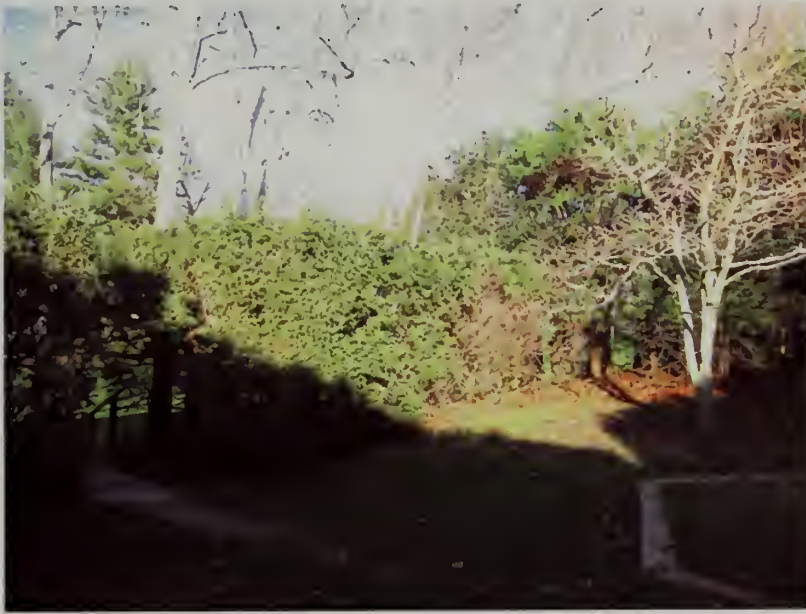
Figure 3.31: The Adams hedge, view looking northeast at sections H-15 and 17, 2006. Note weak canopy and recent dieback from shade of the magnolia tree, and shade cast from adjoining sections (SUNY ESF).

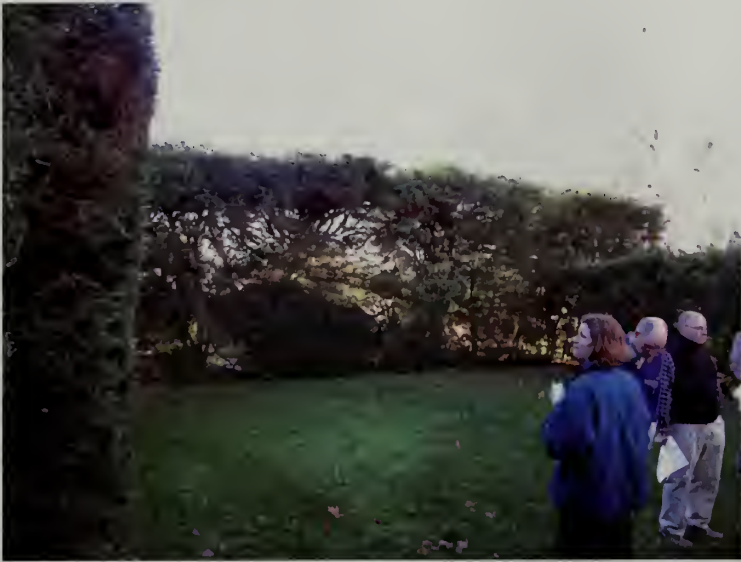
Figure 3.35: The Shaw hedge, view looking west at section H-17, the divide with the Adams hedge, 2006. Note openings in canopy and difference in height with H-18 at right (SUNY ESF).

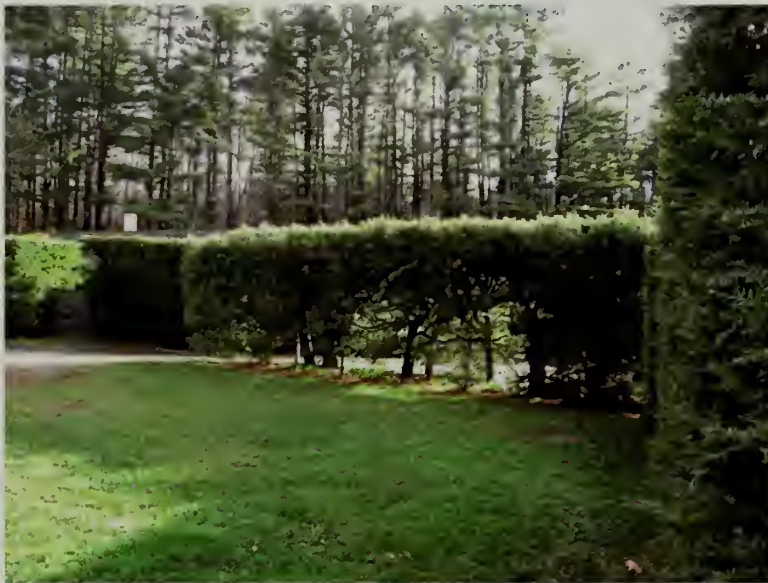
Figure 3.38: The Shaw hedge, view looking south at dogleg (H-20) showing weak lower canopy, 2006 (SUNY ESF).

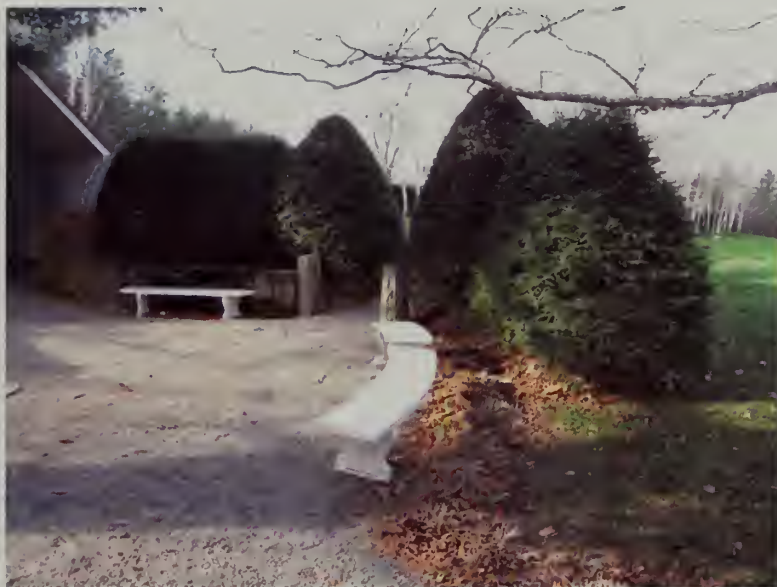
Figure 3.41: The galleries entrance hedge, view looking southwest from interior of courtyard, 2006. The missing north end of section H-23 is in the foreground (SUNY ESF).

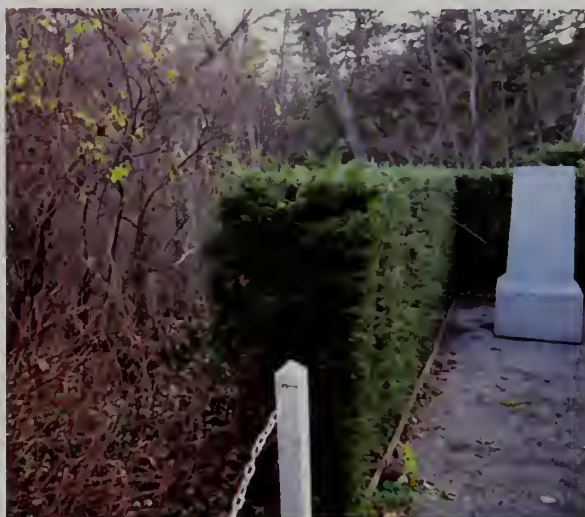
Figure 3.43: The north side of the Lincoln bust hedge, view looking east from Atrium showing encroachment of volunteer vegetation, 2006 (SUNY ESF).

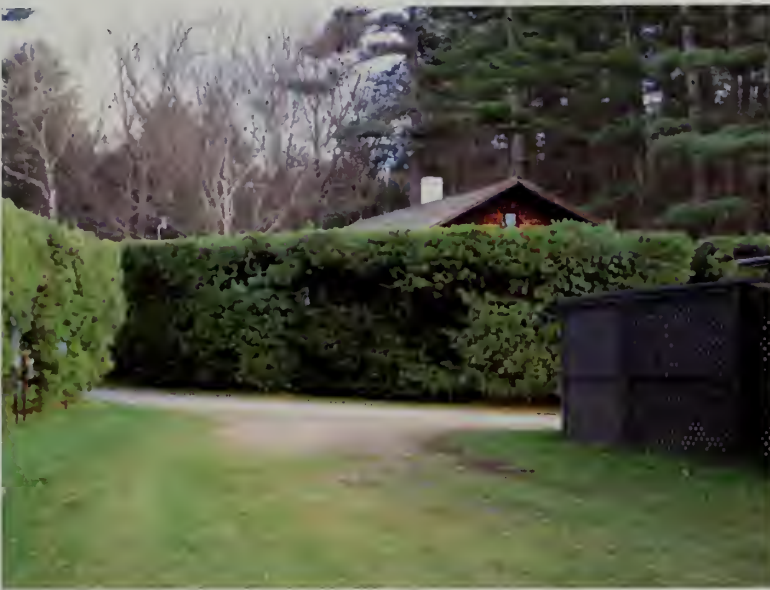
Figure 3.47: The Caretaker's Cottage hedge, view looking east from the stable, 2006. Note existing height above eaves of the cottage and mixed white pine-hemlock (SUNY ESF).
